INFLOW & INFILTRATION SOLUTIONS AND EQUIPMENT

Supplement to:  
MUNICIPAL  
**SEWER  
&  
WATER**

# Keeping It In-House

Sewage authority promotes  
productive DIY culture

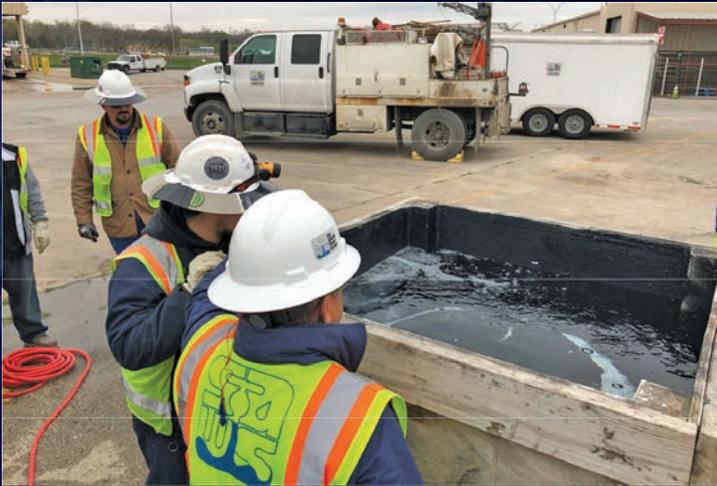
*City I&I Test on CAP Cover*

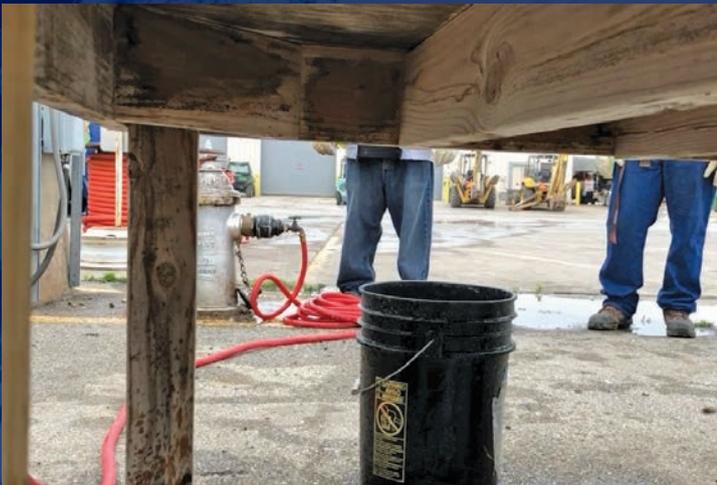
*No Flow Through*

## 0.0 Gallons/ Minute Flow

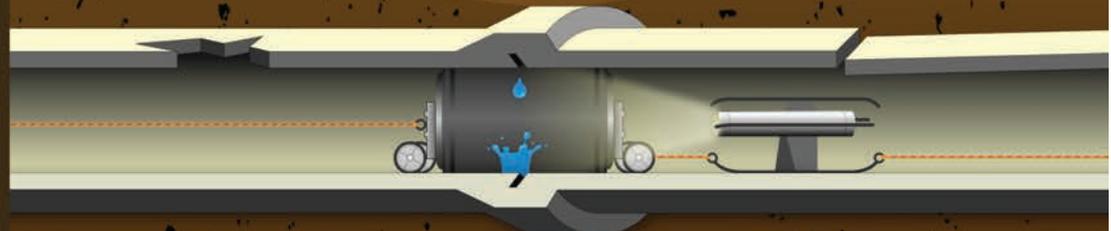
# STRUCTURAL POINT REPAIR in 5 QUICK STEPS

1 CCTV locates defect in pipe

2 Packer and repair sleeve pulled into place

5 CUES LOCK mechanical sleeve permanently installed

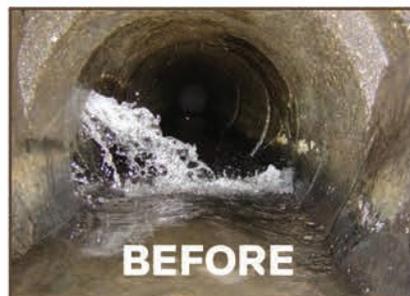
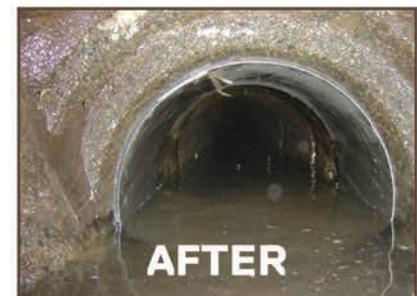
- Structural point repair systems for stand-alone spot repairs in pipes 6"-108" in diameter
- Repair sleeve lengths are available from 12"-36"
- Point repair for cured-in-place failures
- Easy to install - CUES LOCK mechanical point repair systems are easy to install in under 30 minutes
- CUES offers sales/support and stocks repair sleeves at our service locations nationally
- Low cost start-up and requires very little equipment
- Works with any CCTV system and in any pipe material
- 10 year warranty and 50 year half life

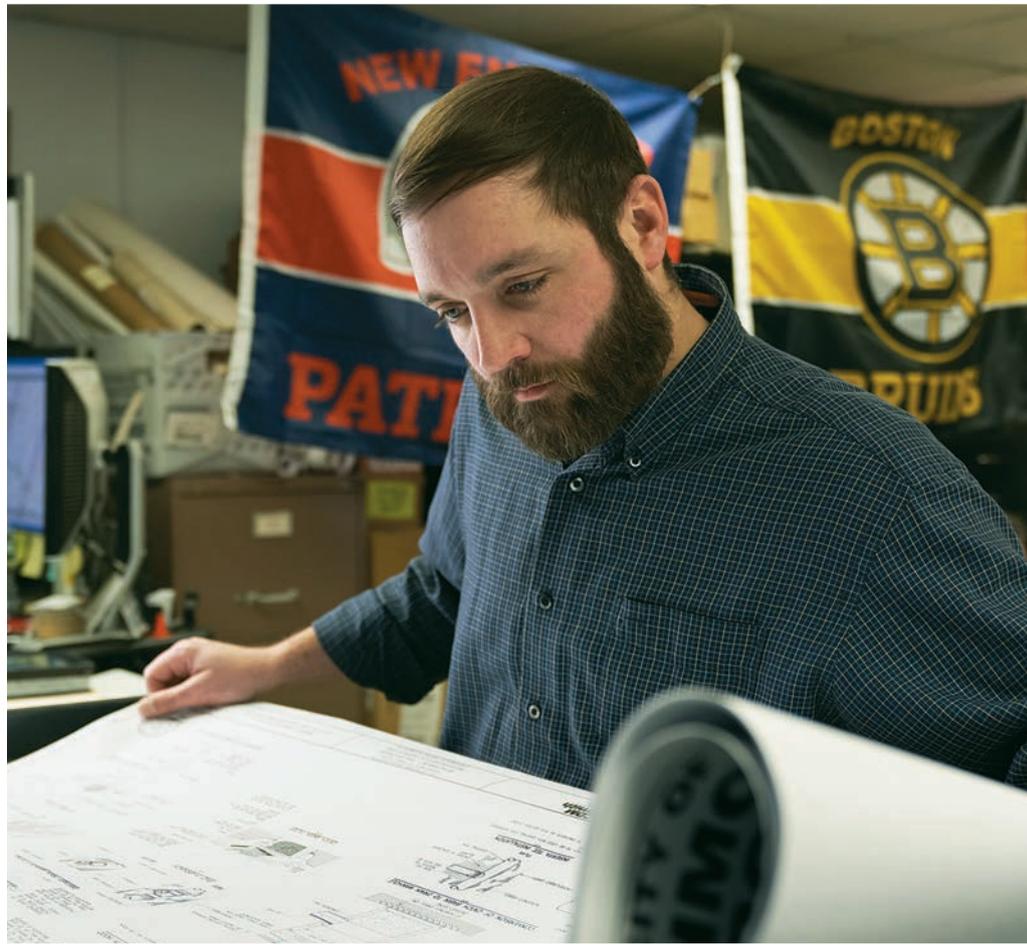
RIGHT: Nicholas Rystrom, city engineer for Revere, Massachusetts, checks designs in his office. BELOW: Crews work on a point repair near Wonderland Greyhound Park, a former dog racing track.

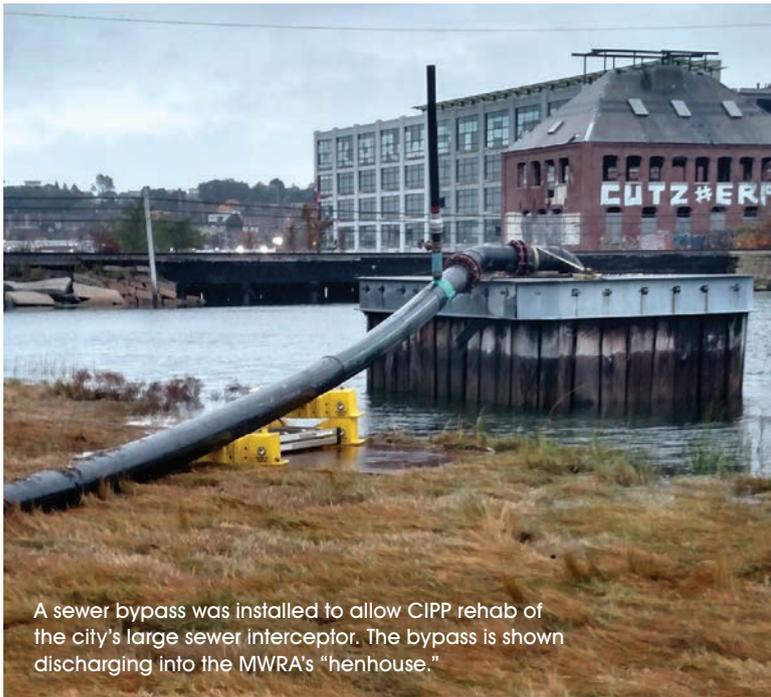
A sewer bypass was installed to allow CIPP rehab of the city's large sewer interceptor. The bypass is shown discharging into the MWR's "henhouse."

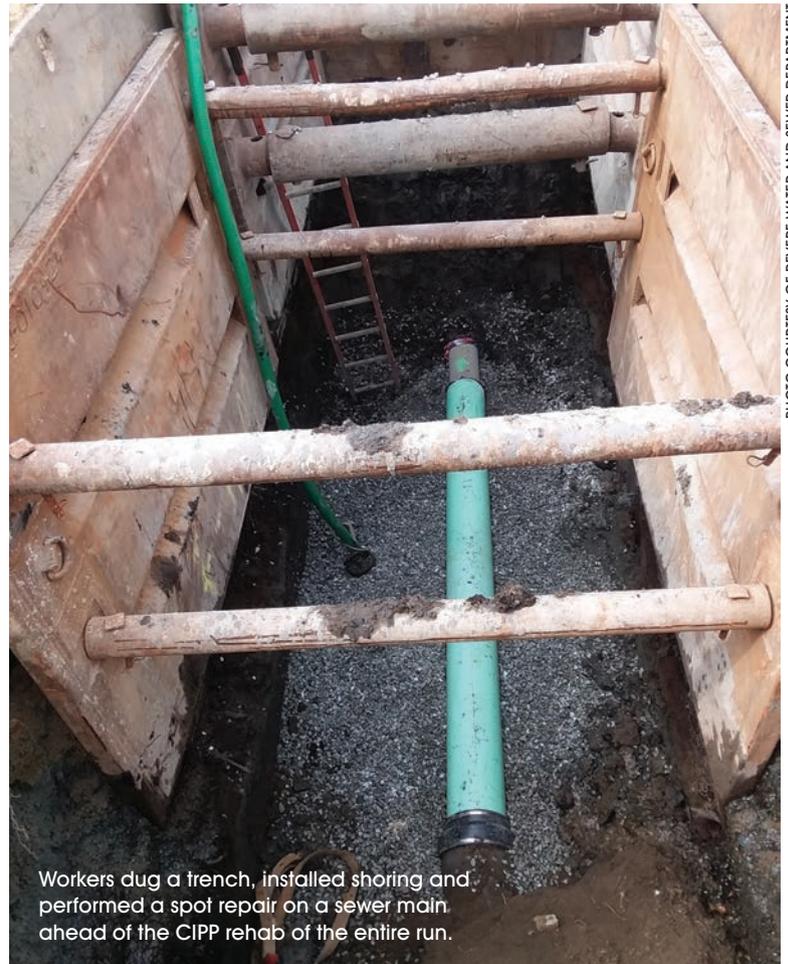
Workers dug a trench, installed shoring and performed a spot repair on a sewer main ahead of the CIPP rehab of the entire run.

The lining of the mainline sewer was straightforward. CCTV inspections using CUES products were performed to determine if the pipe was in good enough shape to get the CIPP treatment. If the pipe was broken or had a severely offset joint, crews would perform spot repairs before lining. Rystrom says that in some cases, they found dead ends on the mainlines with no structure for clean-outs. In those instances, manholes were added. CDM Smith also recommended including pipe seals or hydrophilic end seals as part of the CIPP lining process to eliminate extraneous flow into the adjacent manholes.

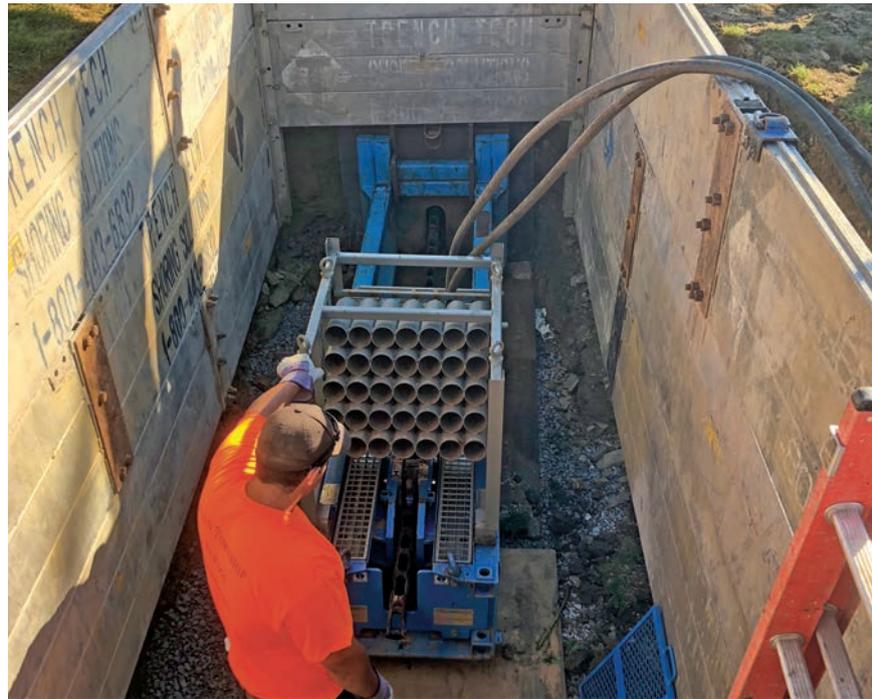
For more than six years, the Penn Township Sewage Authority has rented pipe-bursting equipment from TT Technologies to keep costs down while it pursues I&I work. The hydraulic-powered Grundoburst 800G model the authority typically rents pulls the head through sewer lines with 200,000 pounds of pullback force and can split iron or steel pipe.

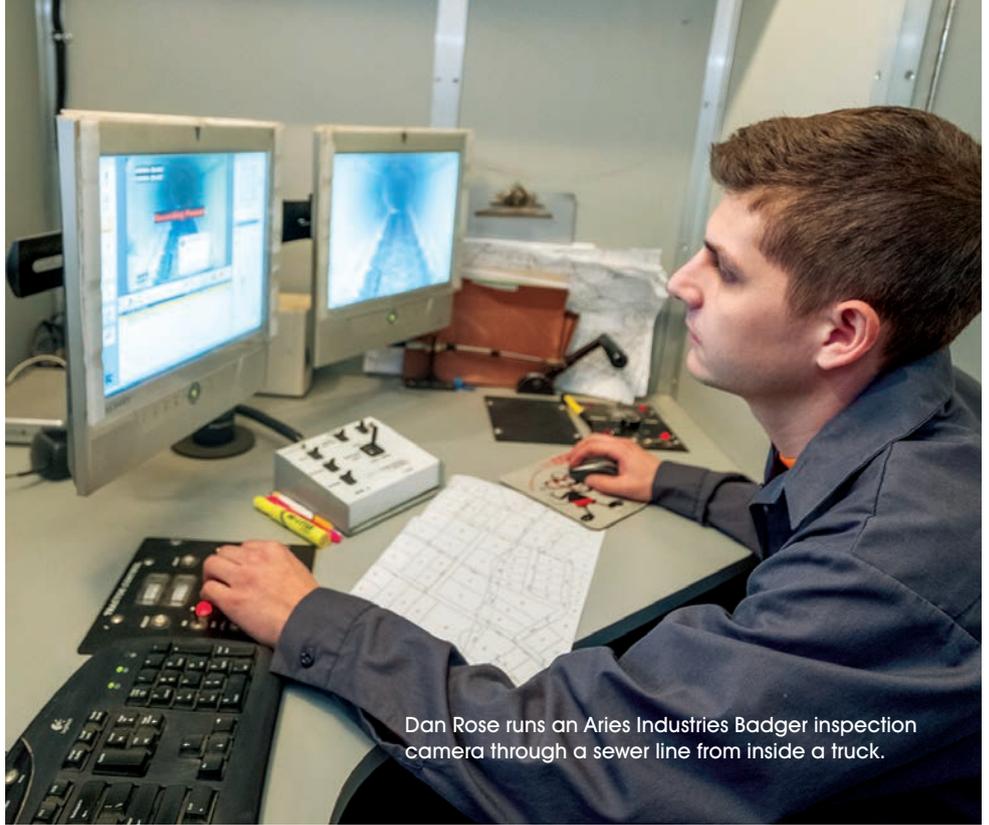
Dan Rose runs an Aries Industries Badger inspection camera through a sewer line from inside a truck.

So, Caroline and his field supervisor determine which sections of pipe are most in need of repair, sending an Aries Industries Badger pan-and-tilt camera into the pipe for close-up inspections. The men work up project

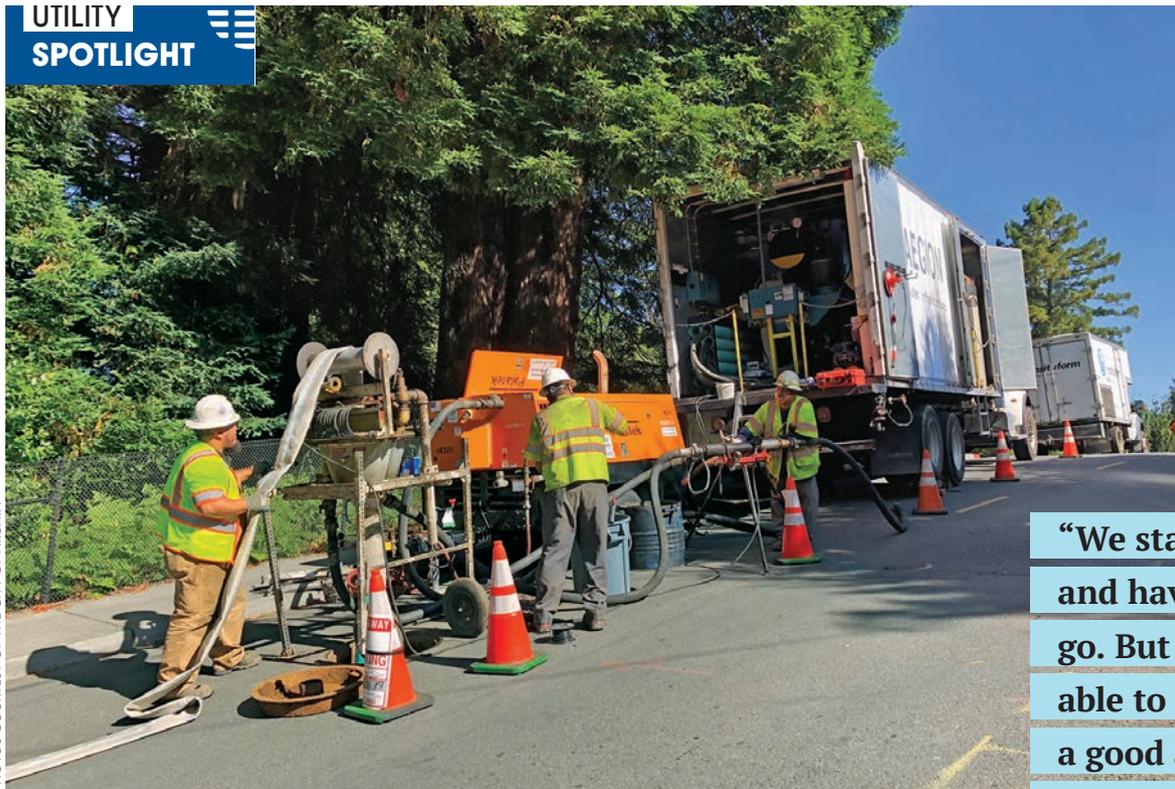
Subcontractor Aegion Insituform installs heat-cured CIPP liners in sewer mains for the city of Arcata, California.

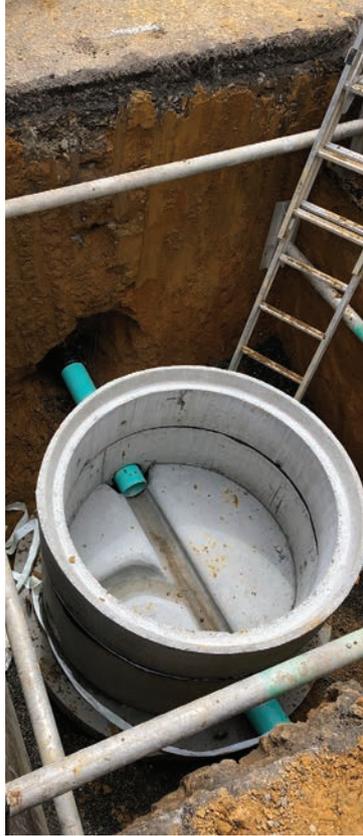
Inflow and infiltration specialist Michels subcontracted on the project to seal 22 leaking manholes by spray-applying SewperCoat PG sealant.

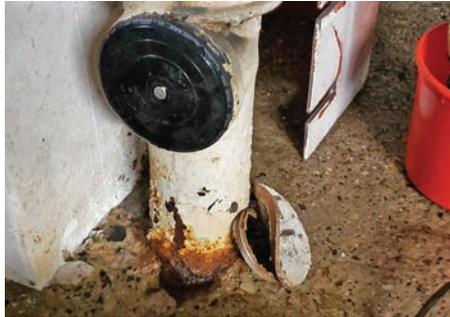
A Minneapolis city inspector performing video inspections in search of sewer lateral breaches and improperly plumbed sump pump violations needed a leakproof clean-out plug that could seal fouled, damaged threads.

The inspector replaced the old damaged clean-out plugs with new flush-fitting **Real-Tite expansion clean-out plugs**.

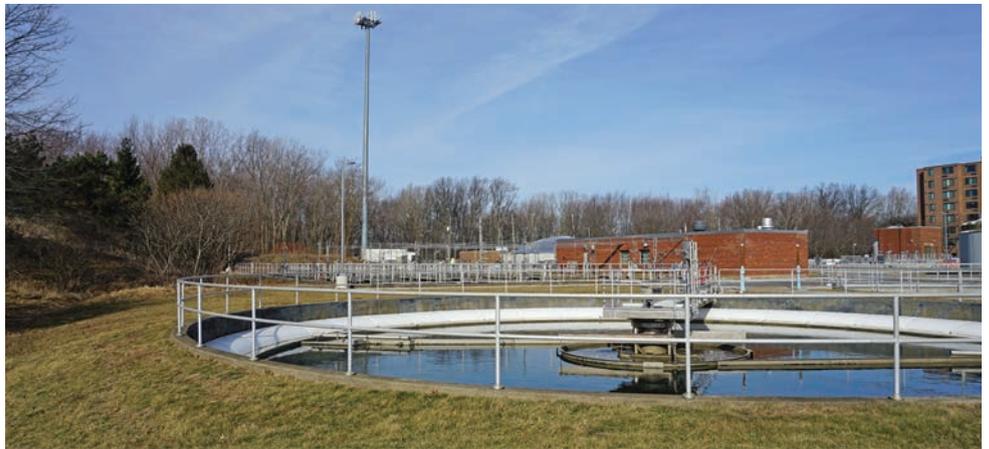
Avon Lake (Ohio) Regional Water's water reclamation facility provides the community's need for safe wastewater treatment. It has a capacity of 6.5 mgd and can accept flows as high as 12.5 mgd during wet-weather periods.
