UTILITY SPOTLIGHT: A Two-

iandimag.com Summer 2020

<u>SEW,ER</u> WATER

Trenchless veteran attacks I&I at its sources Page 8

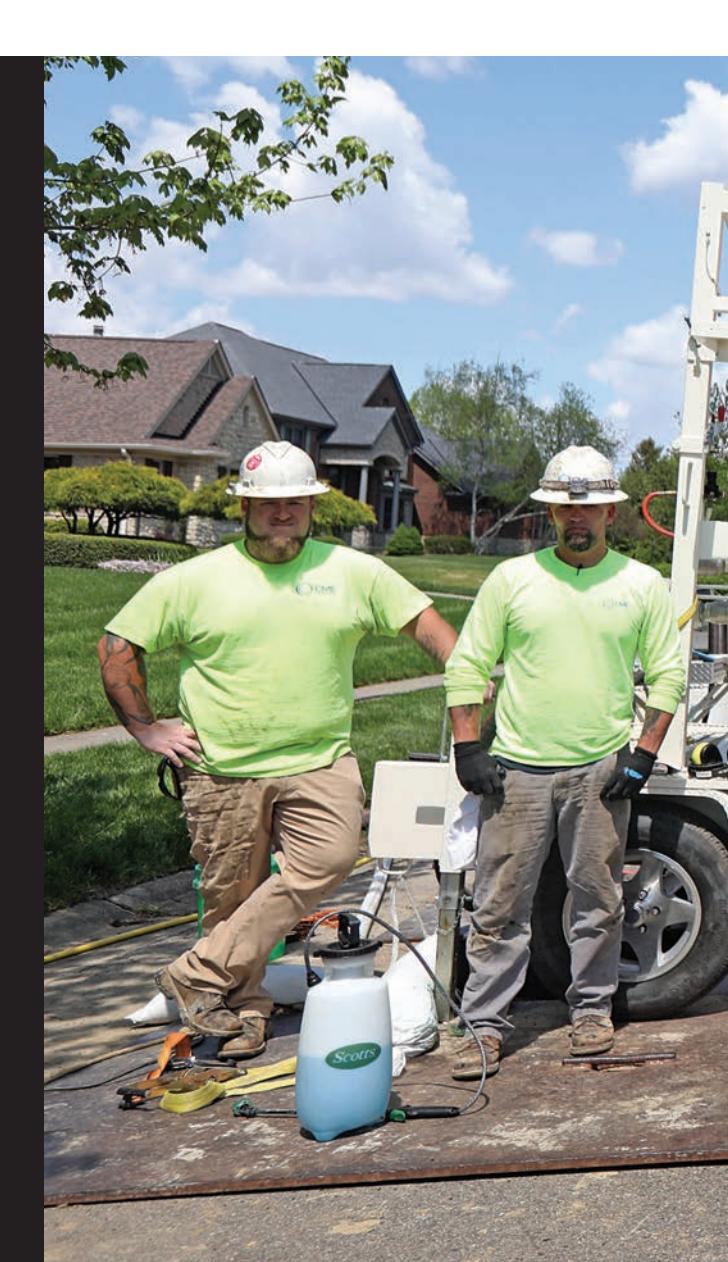
Trammell uses a wireless headset (Sonetics) to communicate with his peers while working to line a 202-foot section of a 30-inch storm sewer running under homes and a golf course in Loveland, Ohio.

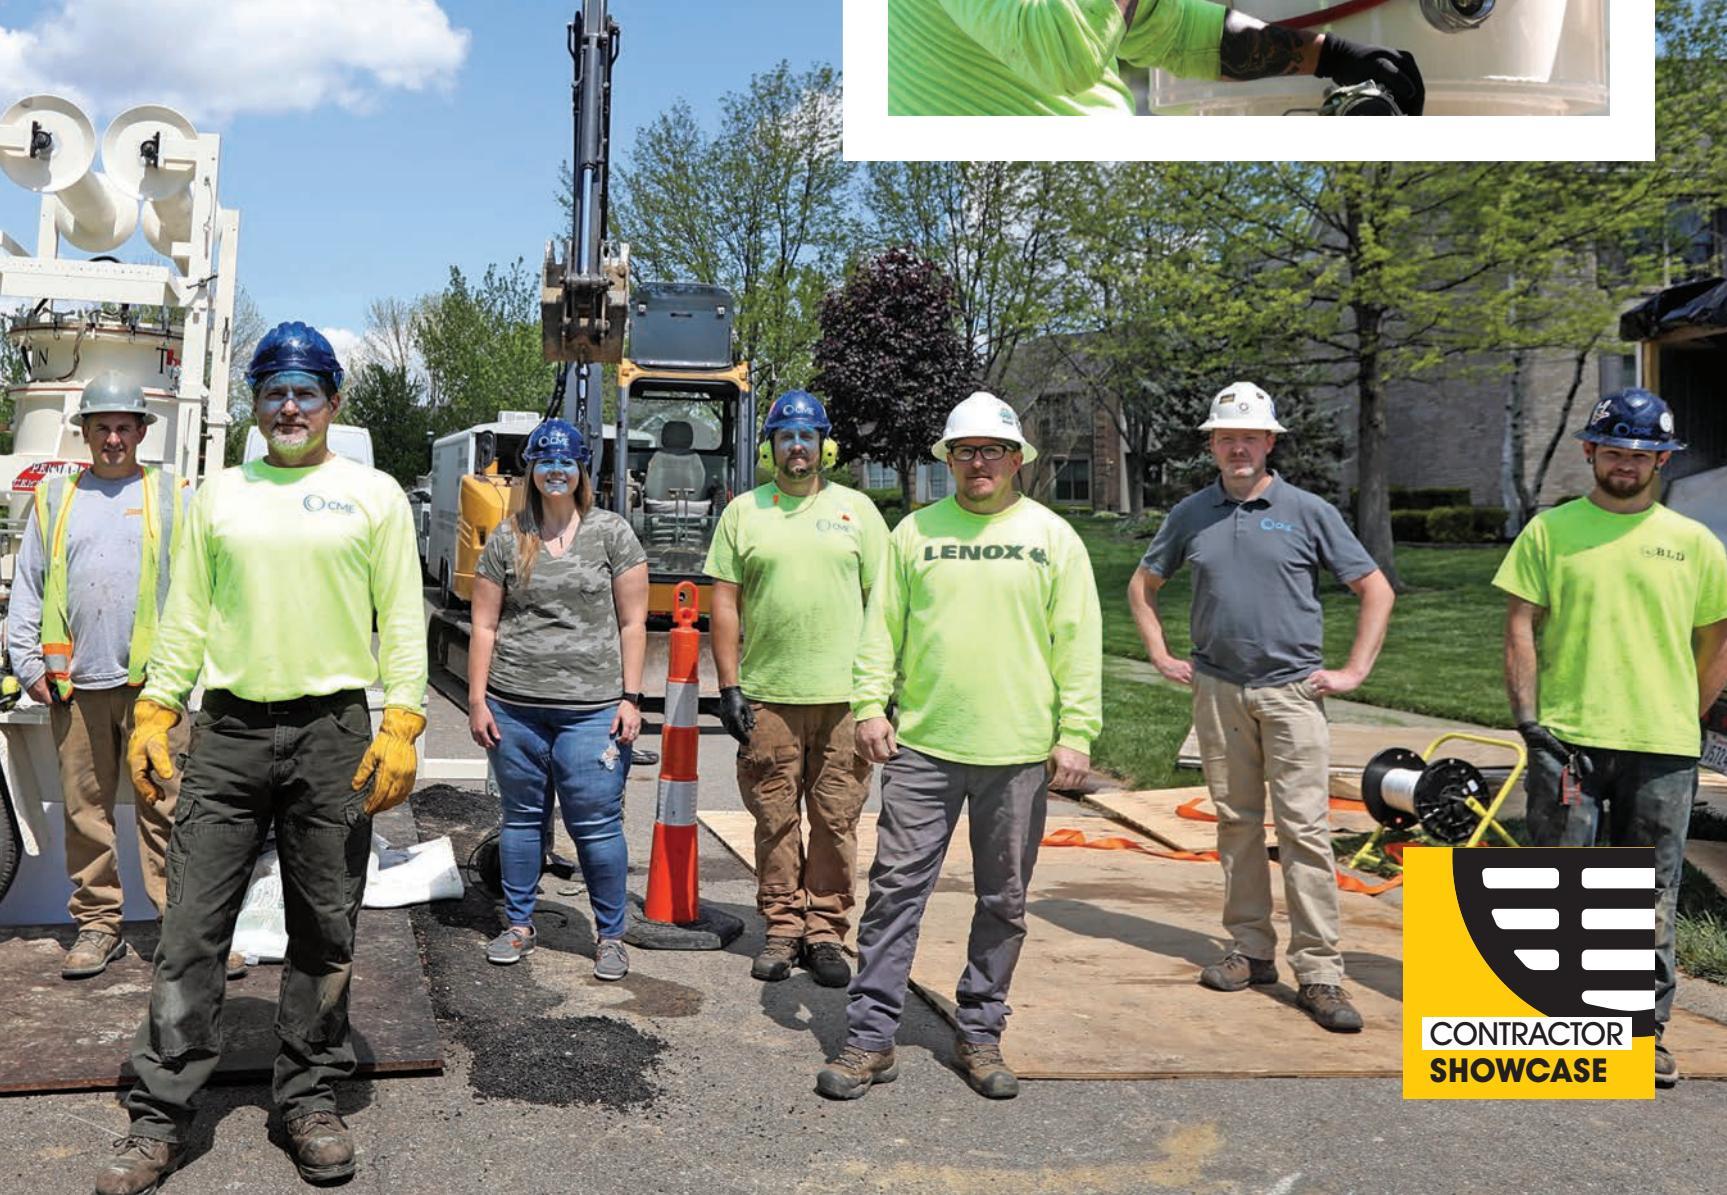
From left, Charlie Knapp, Josh Dickson, Derrick Klotter (in the John Deere excavator) and Jake Ward work together to line a storm sewer using a Perma-Main Top Gun and Viper Steam Cure system from Perma-Liner Industries.

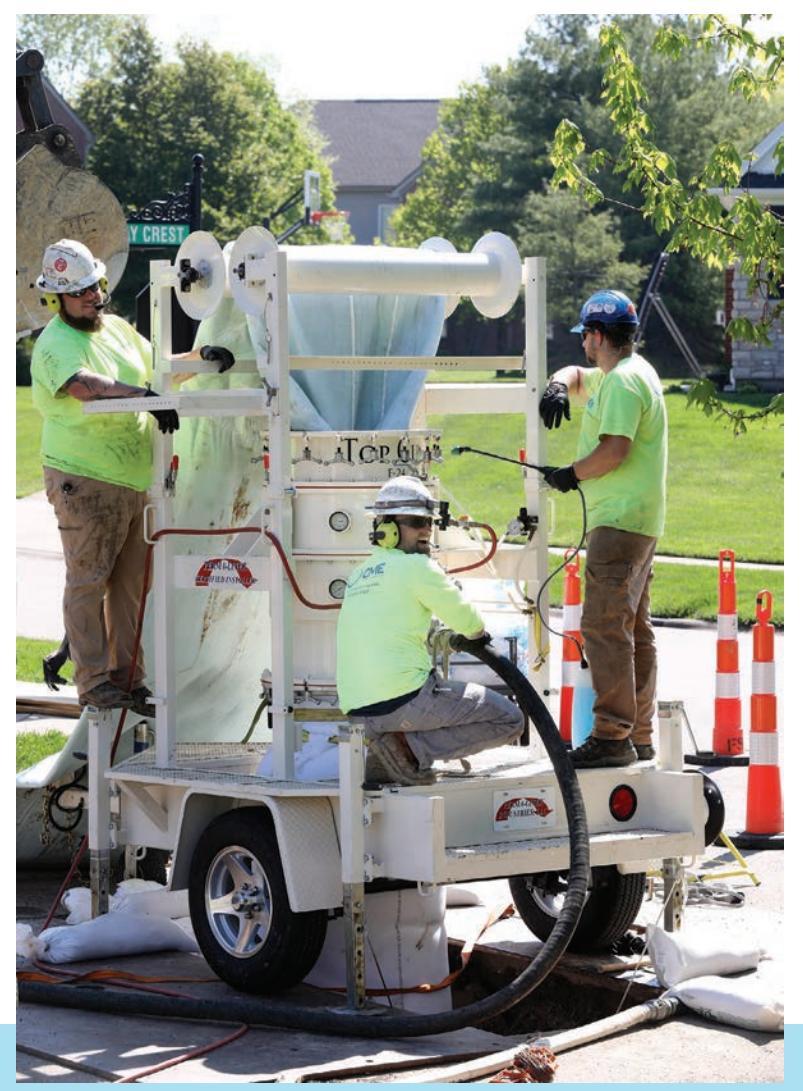
From left, Josh Dickson, Craig Trammell and Charlie Knapp perform CIPP rehab on a sewer pipeline via manhole using the Perma-Main Top Gun inversion system by Perma-Liner.

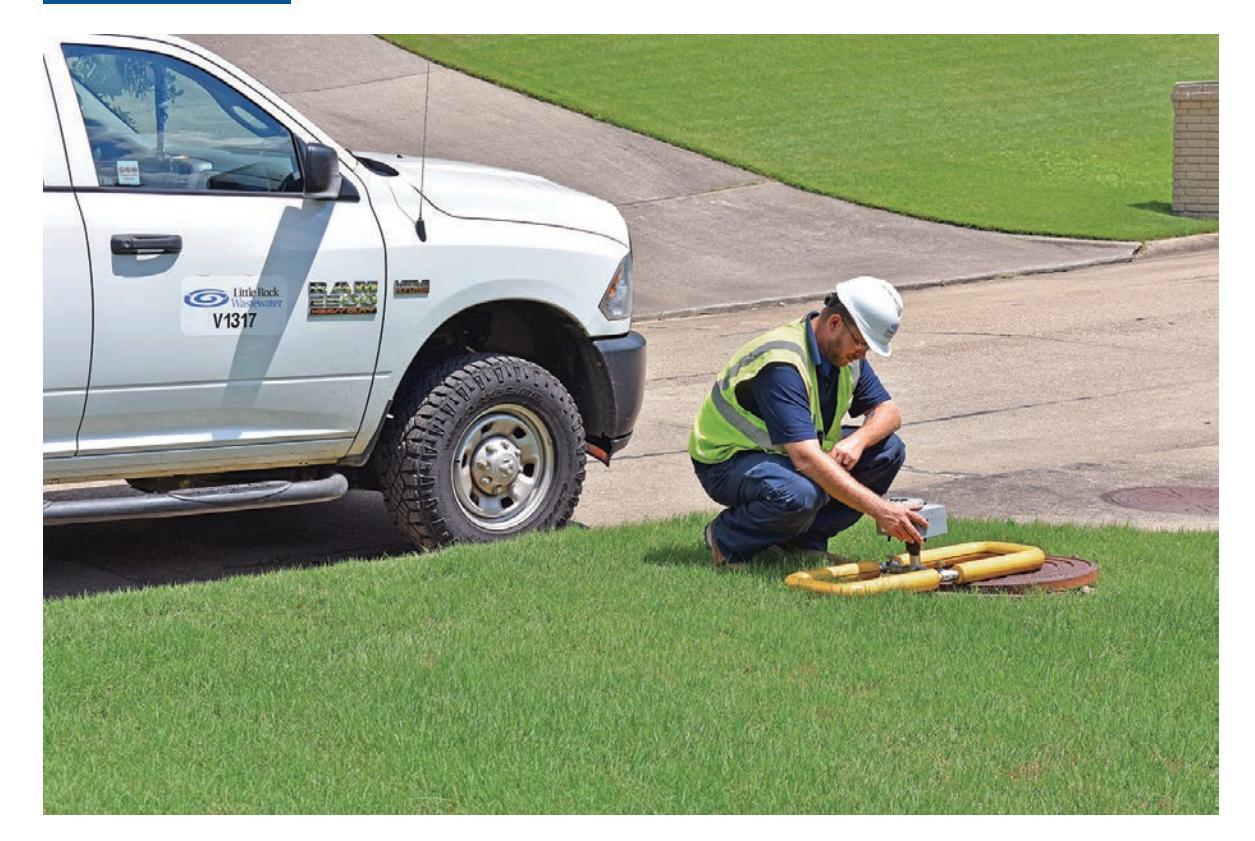
Rather than committing to clean out sewer lines whether it's needed or not, the Little Rock (Arkansas) Water Reclamation Authority is using acoustic monitoring to identify pipelines that need attention. Here a worker uses the Sewer Line Rapid Assessment Tool, or SL-RAT, by InfoSense on an inspection.

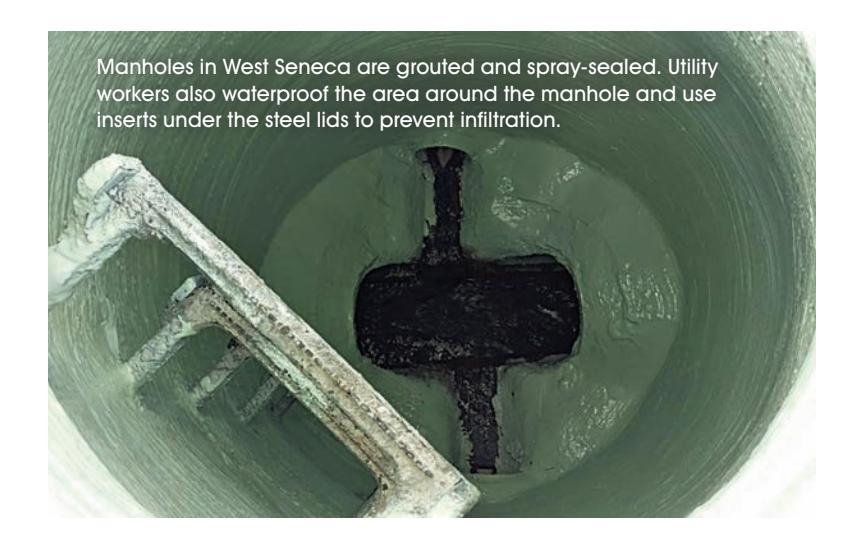
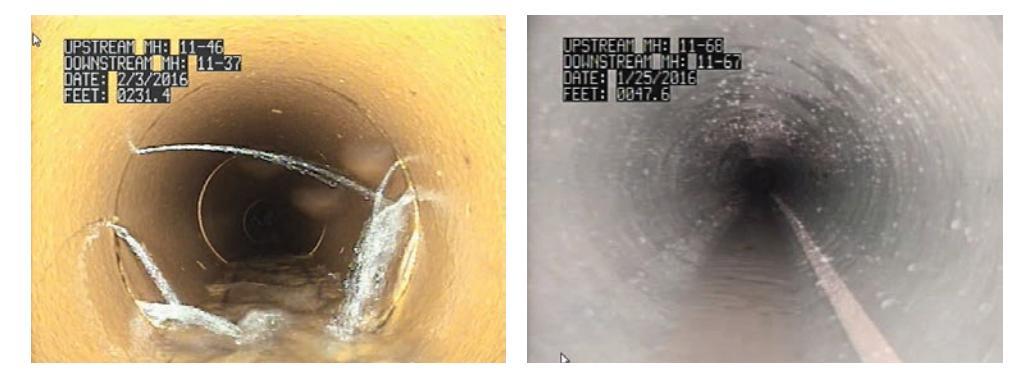
The left image shows obvious infiltration issues on a pipe underneath Lind Avenue in West Seneca, New York, while the right shows a lined and rehabilitated pipe on Leaside Drive.

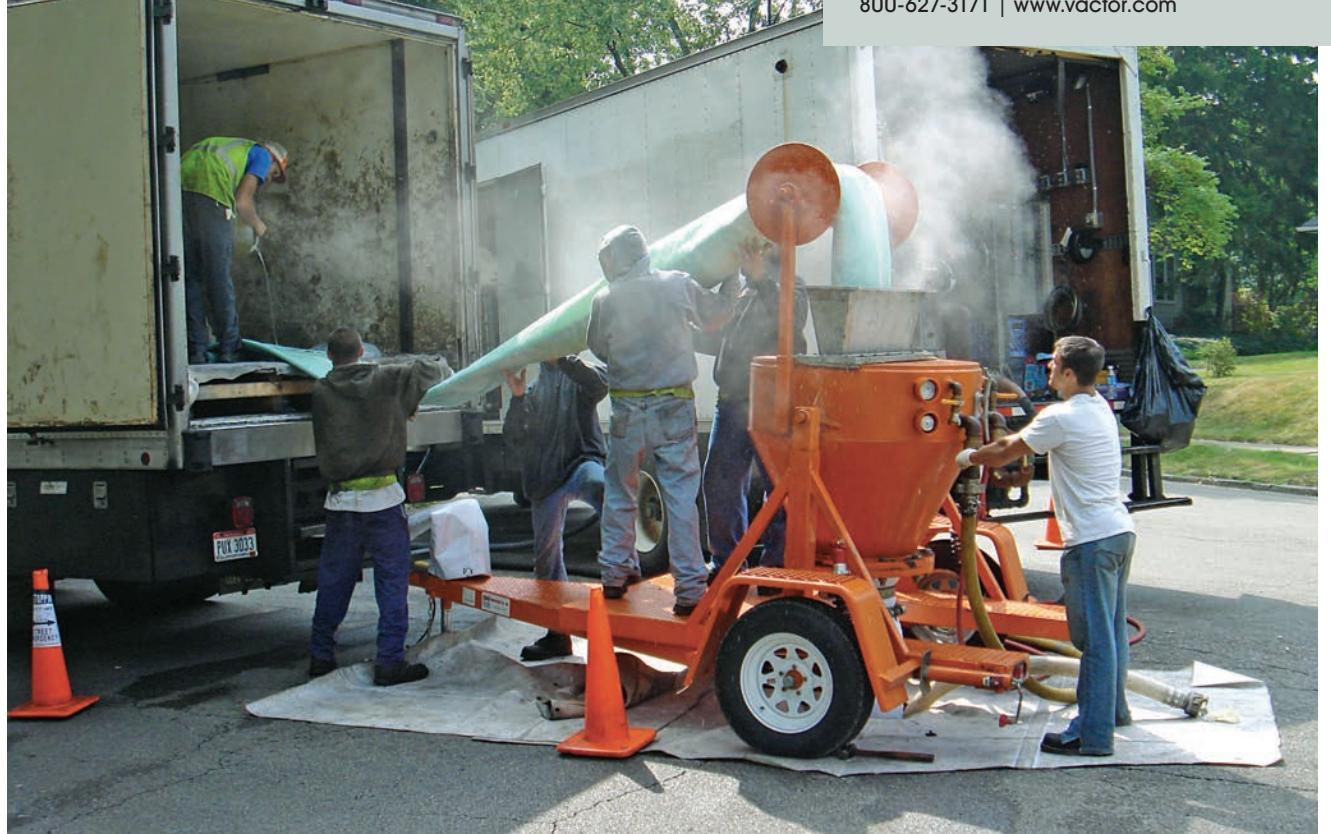
Workers feed a liner into a CIPP pipe inversion machine called THE SHOOTER, manufactured by Emagineered Solutions. West Seneca, New York, officials consider the use of CIPP a no-brainer for many pipe rehabilitation projects, as it delivers a reliable and sturdy product and is less costly to install.

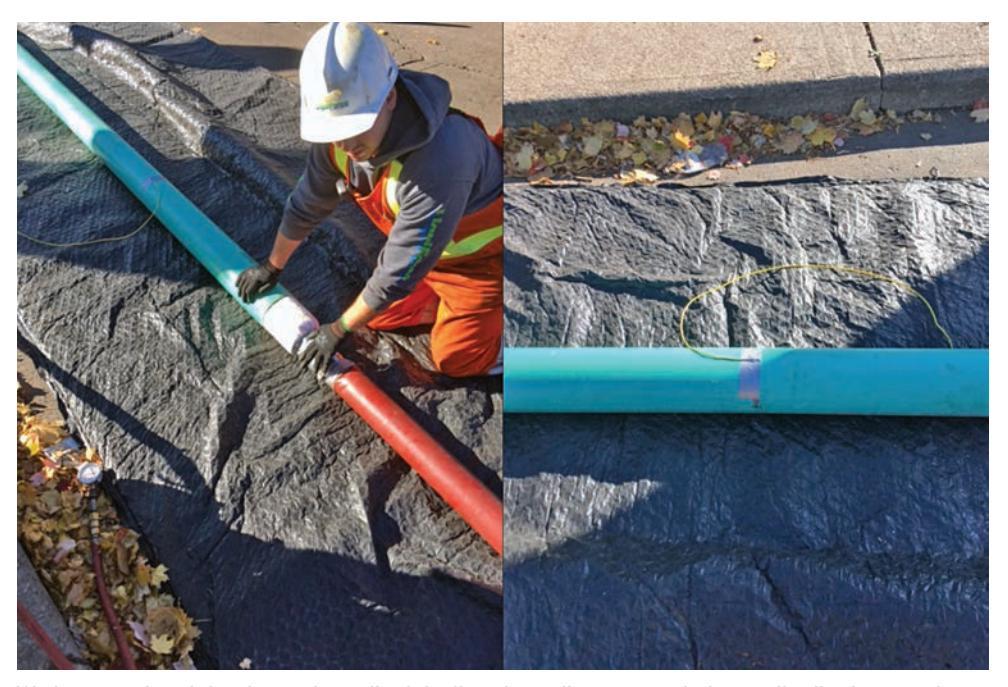
Workers create a lateral sample on the job site using a thermocouple to monitor the temperature and ensure a comparable proxy.

"It is important to recognize that trend analysis is far more important than just the individual test results because samples are not taken from the actual installed liner, but rather independently created."

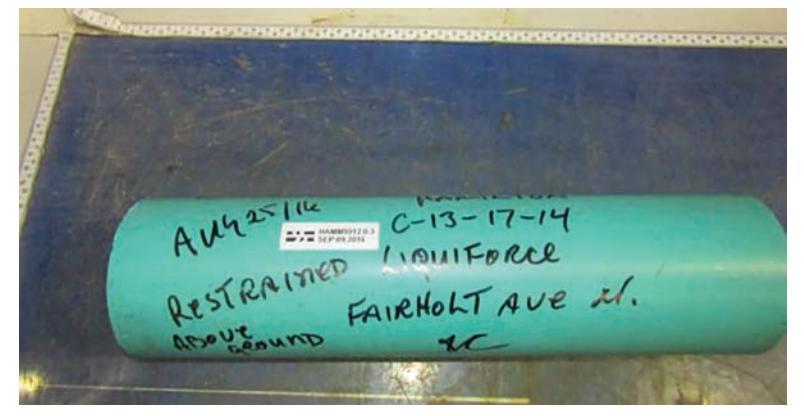
Cured proxy samples using lengths of PVC pipe are marked with the installation date, street name, contract number, contractor name, contractor crew, inspector's signature and any special design requirements.

After a sample is completed, it's cut in half and both the utility and contractor keep a sample for records, which offers the ability to perform primary testing and, when necessary, secondary testing. The samples are identified with the installation date, street name, contract number, contractor name, contractor crew, inspector's signature and any special design requirements.
